DO IT RIGHT THE FIRST TIME

T P Singh

Construction research technologies, N. Delhi, India

Keywords: Hollow core slabs, Strand-Bond failure, Voids, Compaction.

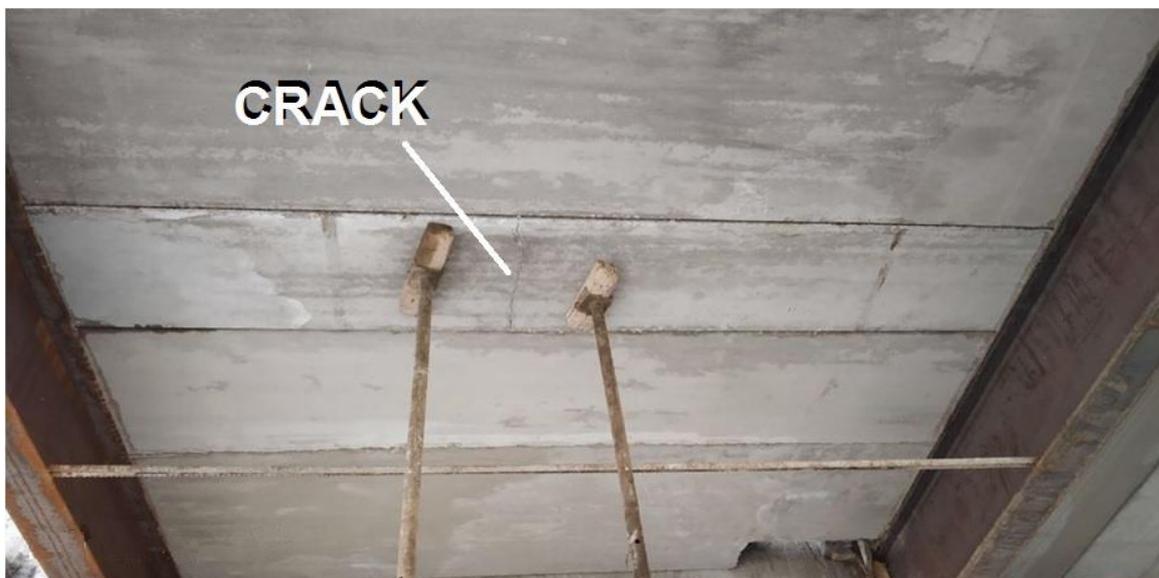
A week after screeding, an HCS half slab on the 6th floor, 600mm wide & 4m long, developed a major bottom crack at its mid-span. The crack widened quickly and had to be removed by the next day to avoid an accident.

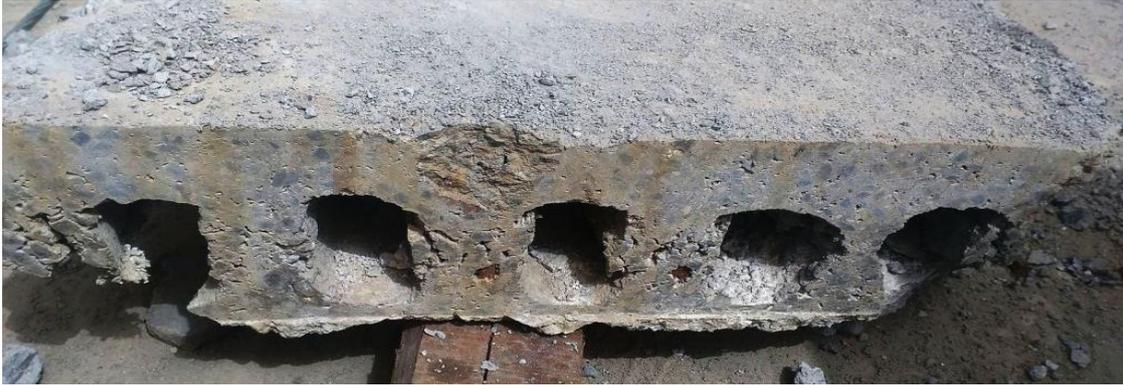
In the case under study, the HCS plank suffered a midspan bottom crack across full width – indicative of a sudden flexural failure.

A Lab testing programme on the failed slab (Ref. Appendix A) revealed that the **concrete quality in SFH 103 was quite variable, with honeycombing & loose, poorly compacted concrete** in some areas, resulting in a poor strand bond. All the 3 strands at one end of the slab were debonded. Both the strands in the slice near midspan had a low bond strength of less than 1 Mpa. Only in the third slice, it took a significant force to push 2 of the 3 strands out of the concrete.

Under the mere self weight and that of the structural topping, the bottom concrete in the plank did not receive any help from the strands to carry tension (bond failure). The concrete cracked at the point of maximum Bending Moment failing the slab in flexure. Amongst the many factors, Lack of compaction seemed to be the most critical cause for bond failure.

1. Consult slip-former machine supplier & rectify machine related causes of un-compacted concrete. This is an Imperative.
2. Optimize the mix design – not only for a target cube strength but also for a target bond strength. A device like a Gyrotory compactor is required for this.
3. Avoid as much as possible – use of extra water at the slip-former.
4. Ensure clean, dust-free & oil-free strands at the time of casting
5. Cuts – longitudinal or transverse to be made only after slab is fully set and has developed requisite strength (Precautionary measure).
6. Curing at yard to be more complete by covering with polythene sheets for at least a week. (Longer the better)
7. Handling at all stages only by certified personnel
8. Packing foam / appropriate material to be used during transit to avoid shocks.
9. Protect from overloading due to accidental impacts

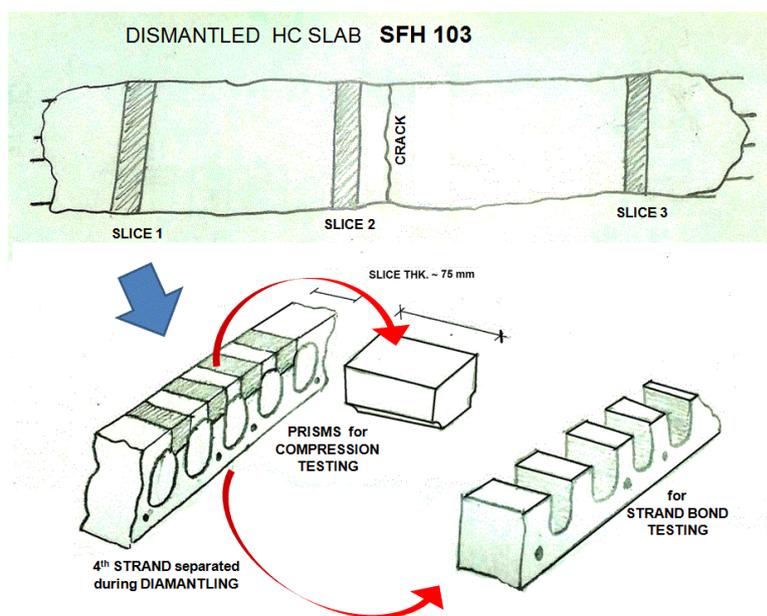
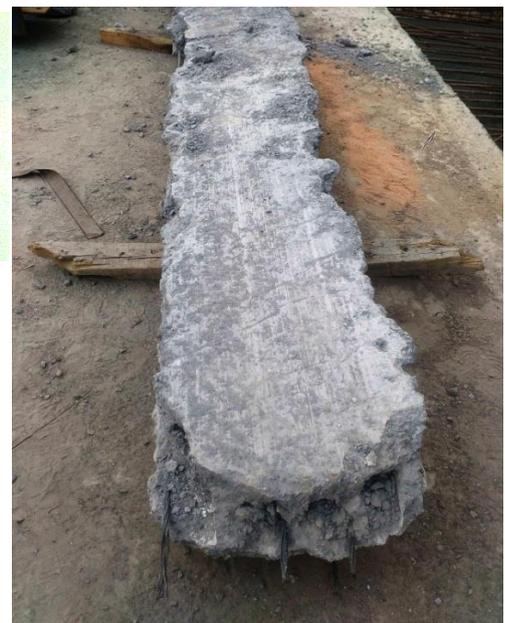
Three slices 75 – 80mm wide were cut from the slab – 2 near each end and 1 near midspan. 4 Specimens in the form of rectangular prisms were extracted from each slice. The bottom portion was retained for strand bond testing.

1. The topping screed was removed with fair ease revealing a nearly clean top surface of the HC Slab, indicating that there was little bond between the structural topping and the HCS.
2. Voids were noticed around strands in several locations.
3. In 2 out of 3 strands of SLICE 1, the strands were FINGER-PUSH LOOSE, while the 3rd was pushed with negligible load.
4. The compression test on the prisms gave a fairly narrow range of strengths – between 24 – 27 MPa.

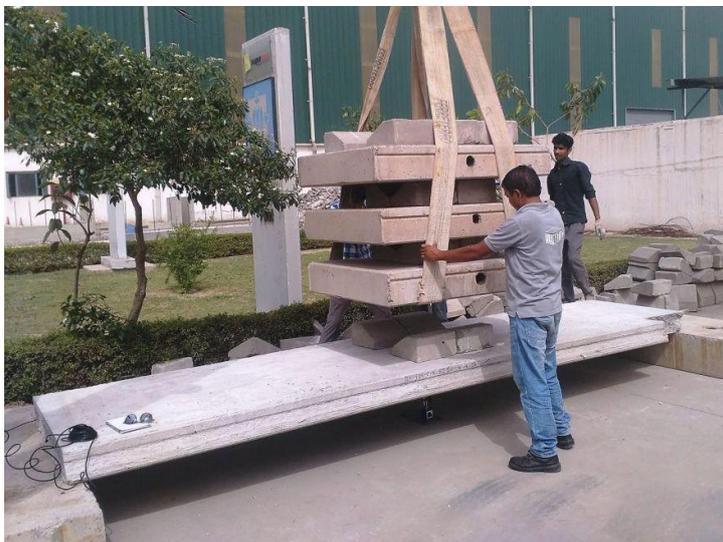
1. Shortlisting slabs on the basis of **visual examination** including a peek into the cores with help of a borehole inspection camera. Slabs with more than 20% of webs indicating honeycombing or lack of compaction were rejected.
2. **Load Testing** the shortlisted slabs with a quick equivalent single load placement in the centre, measuring instantaneous deflection and rebound upon removal. The HC slabs were considered satisfactory if they could sustain the full load for 30 minutes and rebound back 73%.
3. **Strand slippage criterion** The slab was considered PASSED if :
 - the strand slippage was below 2 mm on any of the ends.
 - the slippage was up to 3mm on any one out of 4 strands or 2 out of 8 strands
 - the increase in slippage was less than 0.5mm after the load test

As a result of carrying out this strict selection process on the basis of clearly defined objective criterion, 37 HC slabs were rejected while the rest were cleared for erection. The machine manufacturer's engineers were called in who opened up the whole machinery, corrected the necessary settings to produce further HC slabs whose quality was clearly improved.
