AUTOGENOUS SELF-HEALING OF FIBRE CEMENTS

J Harris¹, Y Zhou¹, J Calabria-Holley¹, K Paine¹

1. University of Bath, UK

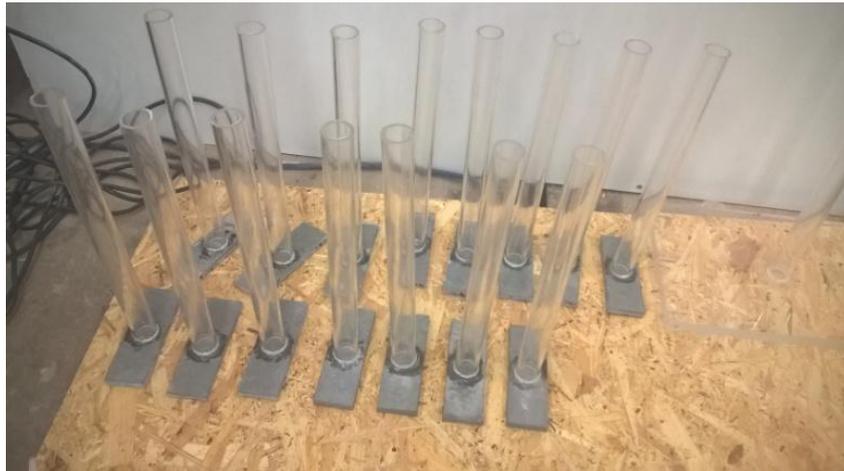
Permeability testing was performed using 300mm long PVC tubes with an internal diameter of 20mm. The tubes were attached to the samples using silicon sealant at the centre point where cracks were designed to form (Figure 1). The tube was then filled with water to a height of 250 mm. Control tests were also carried out on a tube attached to a sheet of acrylic, to account for evaporation over the duration of the test. The samples were left for 24 hours and the change in water height was measured. The loss of water (minus that assumed to be due to evaporation) was taken as the permeability.

Figure 1 Permeability testing of fibre cements

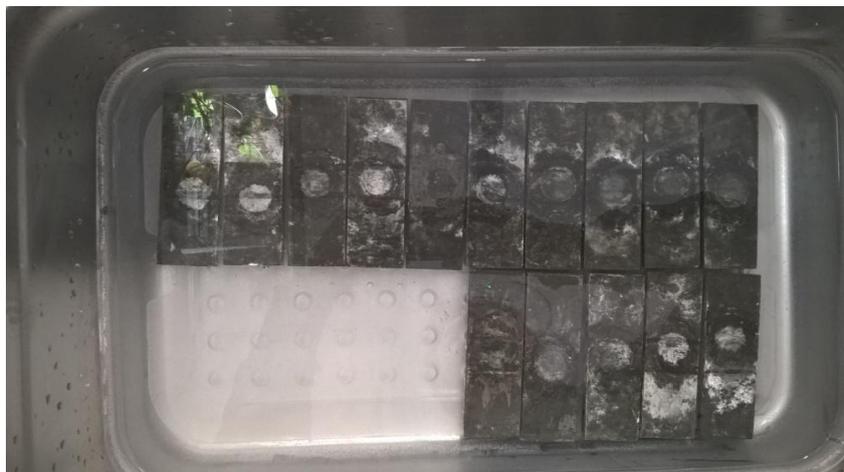
The cracked specimens were placed in a water bath with the crack face up to allow water to enter the crack freely. Water baths were set at 20°C. The samples were left for one week before they were removed and examined for healing (Figure 2).

Figure 2: Cracked fibre cement specimens placed in a water bath to heal
