REHABILITATION OF RCC FLEXURAL MEMBERS USING FRP AND FERROCEMENT OVERLAYS

ABSTRACT. An experimental programme was carried out to conduct a comparative study on the rehabilitation potential of glass fibre reinforced polymer (GFRP), carbon fibre reinforced polymer (CFRP) and ferrocement overlays on RCC beams having different levels of distress. The levels of distresses selected in this study are 70%, 80% and 90% of the ultimate capacity of the beam. The flexural behaviour of the damaged beams rehabilitated with these different material overlays was compared in terms of strength, energy absorption and ductility. Ferrocement showed a consistent performance irrespective of the level of distress. However, both the FRPs showed a gradual reduction in performance as the distress level increases, in which the performance of GFRP decreased at a faster rate than CFRP. It was also noted that FRP and ferrocement rehabilitation are equally effective at very high levels of distress. A comparison of the shear behaviour was also done on shear deficient beams rehabilitated with the above three materials, selecting the distress level as 70% of the ultimate capacity of the beam. FRP appears as more ef

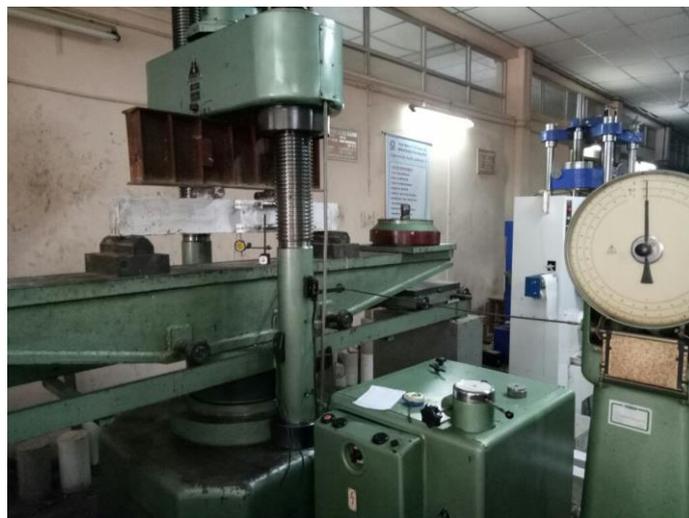
Figure 2 Test setup showing beam specimen with LVDTs and dial gauge

The beams were tested as simply supported beams under four point bending test in a universal testing machine (UTM) of 3000kN capacity. The span of the beam kept as 1100mm. The loading points were kept at $1/3^{\text{rd}}$ of the span. A dial gauge was used to measure the midspan deflection. Two linear variable differential transformers (LVDT) were placed at the mid-span portions to measure the deformations in the tensile and compression region. The schematic and actual test set up are shown in Figures 1 and 2 respectively. The load was applied at an interval of 2kN, and deflections were noted. Crack patterns were noted after the first crack load.

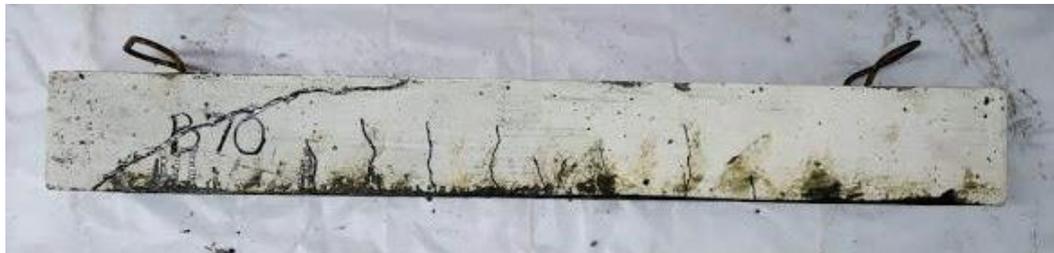
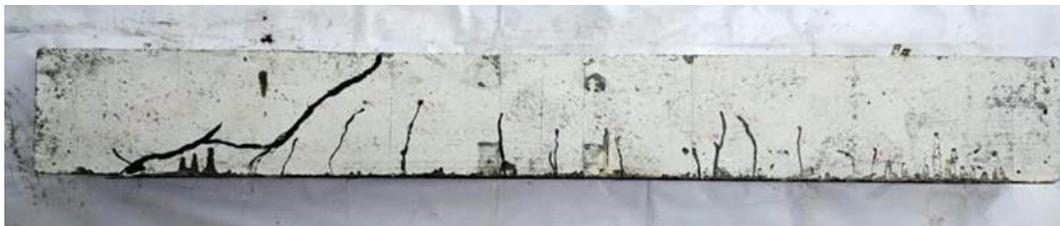
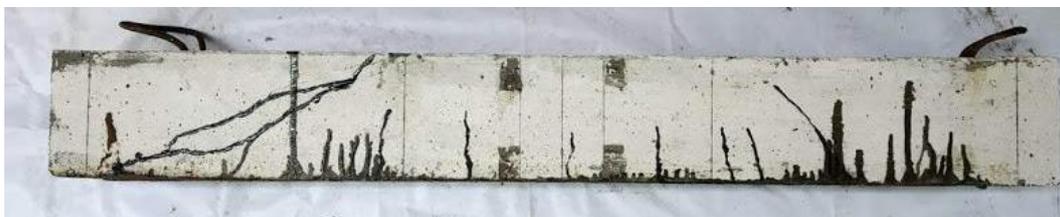
(a) CFRP – 70% DISTRESS

(b) CFRP – 80% DISTRESS

(c) CFRP – 90% DISTRESS

Figure 6 Crack patterns in beam specimens tested after rehabilitation with CFRP (Distress levels before rehabilitation are noted)

The completely cured strengthened specimens were again tested to failure to find the ultimate load carrying capacity, by the four point bending tests in UTM. The cracking patterns were noted for the beams during the tests before and after rehabilitation. The crack patterns on the CFRP rehabilitated beams are shown in Figure 6 (a) to (c) as a typical example.

The cracking patterns showed that after rehabilitation, most of the cracks happened at the same location as the previously happened minor cracks. It may due to the fact that, since the strengthening was given only to the soffit of the beams without repairing the minor cracks,

the stress in steel was more at the previously cracked region which tends to widen the cracks during reloading. Failure of the FRP rehabilitated beams was mainly due to FRP rupture, diagonal shear crack at the laminate end and delamination/debonding initiated by shear cracks. FRP rupture failure appeared in 70% distressed beams only. Other beams were failed due to shear cracks at laminate ends.

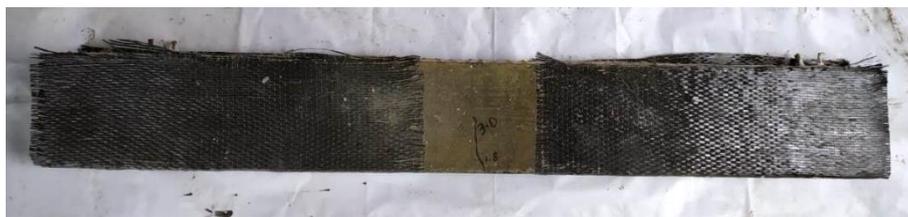
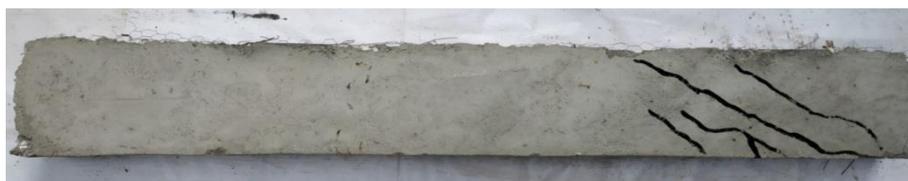
(b) CFRP rehabilitated beam (Side view)

(c) Ferrocement rehabilitated beam (Side view)

Figure 12 Crack patterns on the shear strengthened beam specimens tested after rehabilitation

Figure 12 shows the 70% distressed beams, which were shear deficient, tested after rehabilitation. Debonding of the laminates occurred in the FRPs, and finally failed due to shear cracks. Ferrocement failed with large shear cracks.
