# EXPERIMENTAL INVESTIGATION ON BONDED COMPOSITE PATCH REPAIR FOR AN EDGE-CRACKED AA 1080 ALUMINIUM ALLOY PLATE

**ABSTRACT.** Bonded composite patch repair has got a high demand for repairing cracked components and weak aerospace structures because of its highly advantageous properties. These properties allow a significant increase in strength and durability. In this study, the experimental investigations on cracked and uncracked specimens of AA 1080 aluminium plates repaired with single-sided 4-ply glass/epoxy composite patches were represented. The AA 1080 aluminium plates were having a thickness of 3 mm. In accordance with the ASTM standards tensile, flexural and charpy, impact tests were conducted on the repaired structures to characterize its response. The aluminium specimens having three different crack lengths along with the patch lay-ups were analyzed. The test results that were observed were compared with the results for cracked, uncracked and repaired cracked specimens. As per the comparison it was found that the patching effect on the mechanical properties of the cracked plate is highly significant.

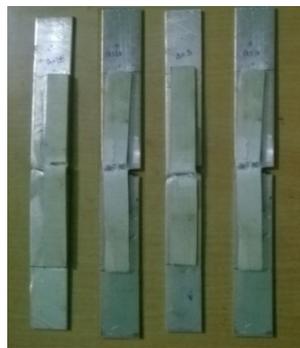
Figure 1 Specimen failure after tensile test

Tensile tests were carried out according to ASTM E8 using universal testing machine UTE-20-HGFL at a crosshead speed of 5 mm/min. The dimension of specimens (250 x 30 x 3) mm and the patch length are 5 mm, 10 mm and 15 mm. The gripping length on both sides of the specimens was 50 mm each and the gauge length was 150 mm. Tests were conducted on both cracked and uncracked specimens and specimens with 4-ply bonded glass/epoxy patches.

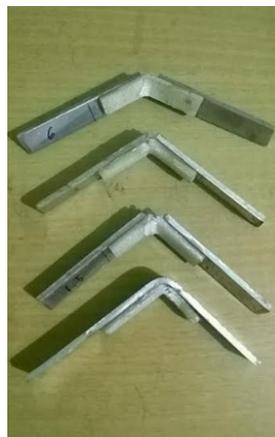
Figure 2 Specimen failure after Flexural Test

Flexural tests were carried out according to ASTM E8 using universal testing machine UTE-20-HGFL mentioned above at the same crosshead speed. The dimension of specimens (50 x 10 x 3) mm and patch length is 1.5 mm, 3 mm and 6 mm respectively. The flexural tests were also conducted on the cracked specimens as well as on the un-cracked specimens with adhesively bonded glass/epoxy of 4-ply patch.
